DNA 4654F

FLAME NOSETIP RECOVERY VEHICLE FLIGHT TEST SERIES

Prototype Development Associates, Inc.
1740 Garry Avenue
Santa Ana, California 92705

Final Report for Period July 1975—March 1977

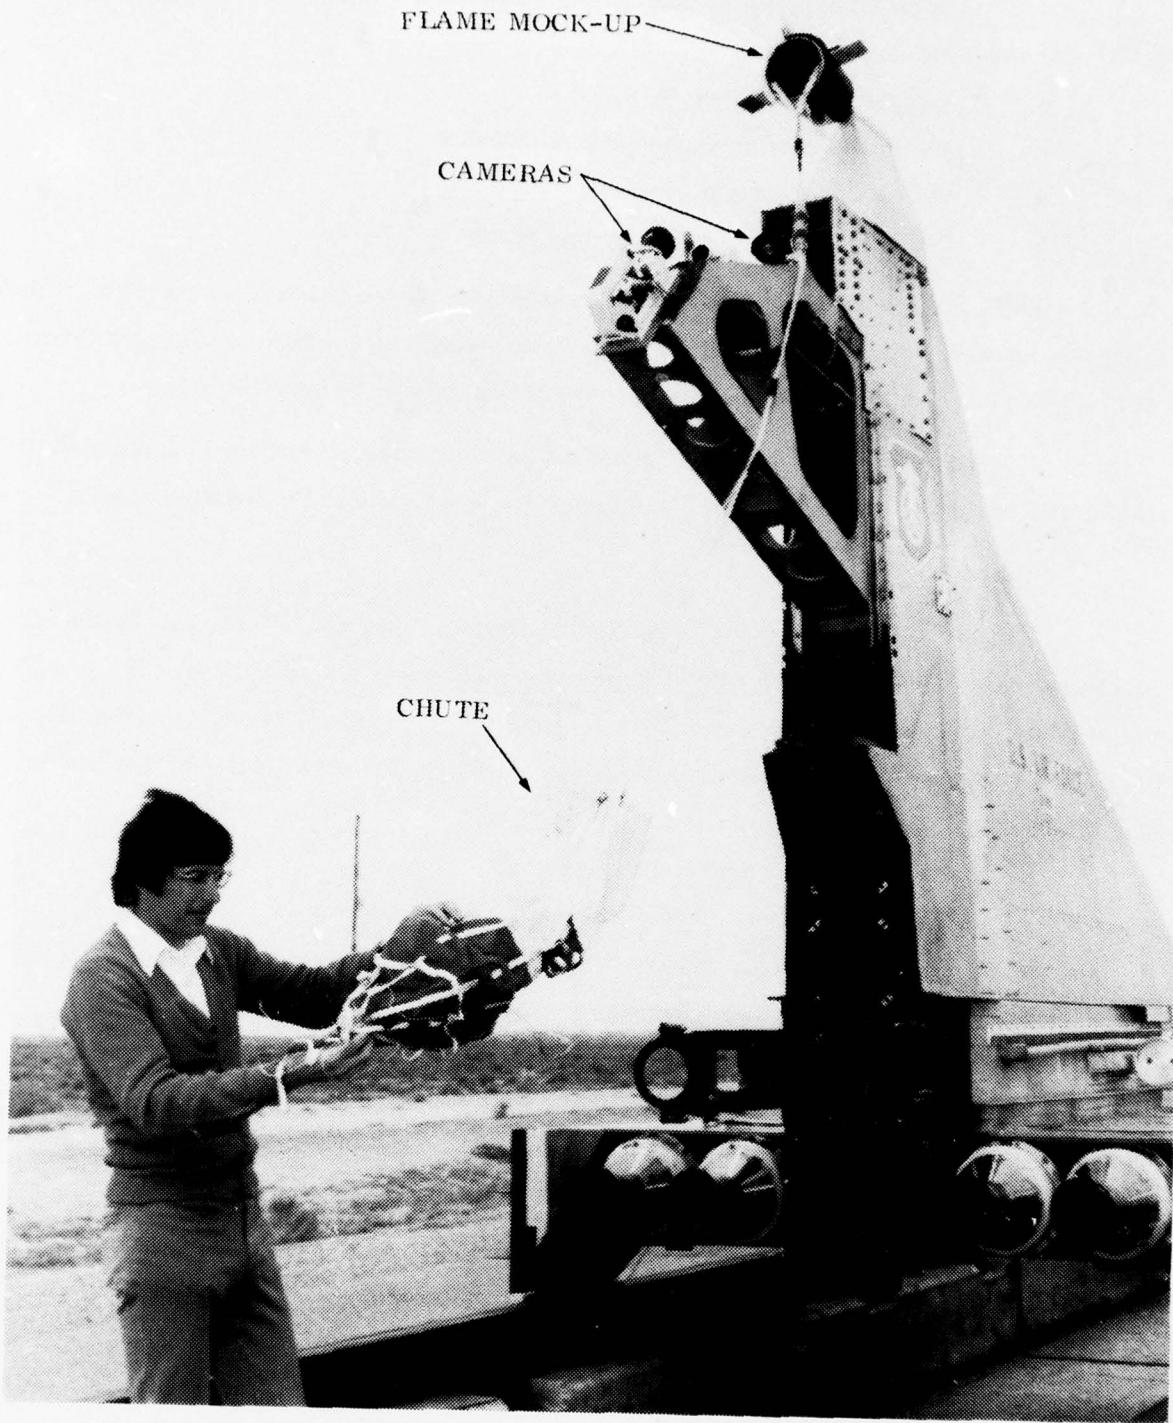
Figure 3-1. Holloman chute test installation.

Verification of the above changes was accomplished by two rocket sled tests at Holloman AFB, New Mexico. Figure 3-1 shows the installation of the vehicle mock-up on the rocket sled.

The first test was conducted on March 12. In this test, the reefing line failed on deployment and the chute tore off the R/V, essentially duplicating the Tonopah failure. Post-test inspection revealed that the reefing line cutters had not been installed securely and had worked loose on deployment. This allowed the reefing line load to be applied directly on the sharp cutter edge resulting in premature failure of the line. In addition, it was found that the shroud line confluence had not been properly fabricated resulting in a sequential tensile failure of all shroud

4
lines. Excellent high speed motion picture coverage allowed these and several additional minor problems to be identified, and remedial action was taken at Irvin Industries on March 13.

A second sled test of the twice-modified system was conducted on March 14 and the system performed satisfactorily in all respects. The reef system worked, keeping the chute loads down during deceleration from 400 psf to 100-150 psf, at which time the reefing line was automatically cut and the chute bloomed to full diameter without parachute damage. Rebound damage to/from the beacon and battery pack was eliminated by the two-step parachute opening. The flotation bag inflated and the sonar pinger stayed in its harness. Post-test movies showed that (1) the deployment sequence was orderly with the new snubbing line modifications, (2) the mortar-sabot cleared cleanly, (3) flotation bag inflation/rebound was improved by reefing the chute, and (4) the swivel permitted orderly deployment while the R/V was spinning at 4-5 rps.

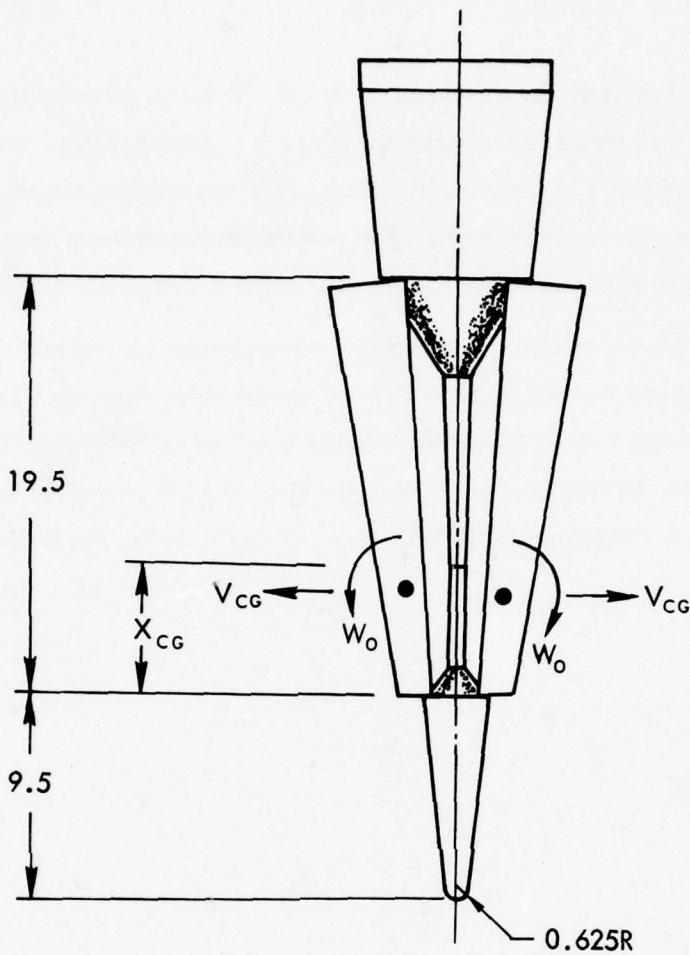
Figure 3-3. Comparison of separation system ground test results.

It is believed that on the third flight, the pyrotechnic system failed to cut the fairing away cleanly (Section 4.0). To correct this problem, the pyrotechnic system was redesigned and was tested at the Space Ordnance Systems, Inc. facility at Saugus, California. The HRV ground test model, equipped with the modified pyrotechnics and a FLAME fairing heatshield, was hung vertically by a flexible cable. The pyrotechnic system was then fired, and fairing deployment was recorded using two 1,000 frame-per-second motion picture cameras. Fairing section position histories were computed by a frame-by-frame analysis of the film data, and the resultant separation velocity and rotation rate (average for the two sections) are shown in Figure 3-3. Inspection of the severed structure and heatshield showed clean cutting action over the full length of both charges.

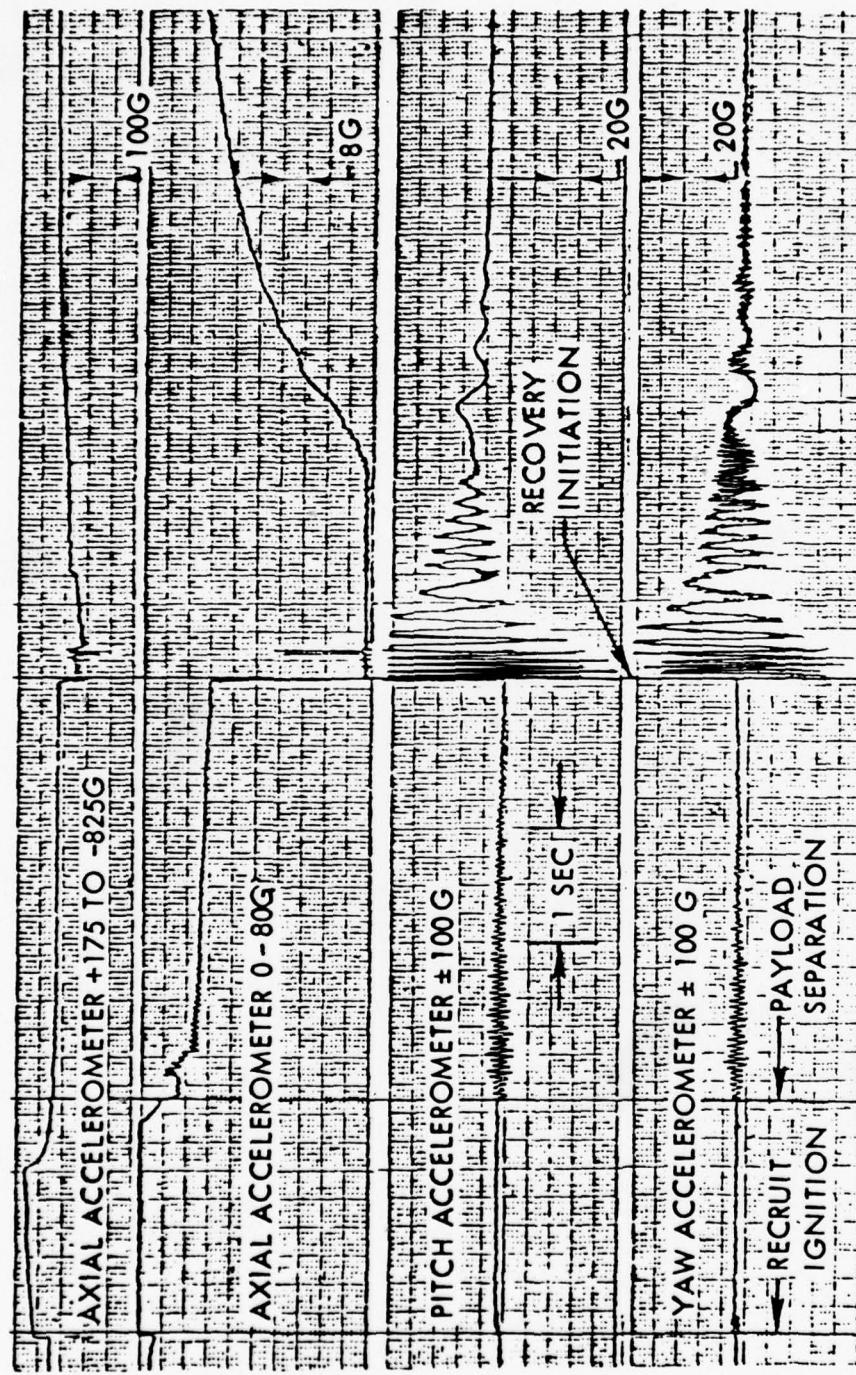
Figure 4-3. FLAME F-002 telemetry.

The mission appeared to be nominal until parachute deployment. The parachute broke away from the R/V when it inflated, and the R/V impacted at high subsonic velocity. The R/V, although heavily damaged by the impact, was recovered and the parachute system was also recovered some distance away. Table 4-6 summarizes the various sources of flight data. The telemetered accelerometer data agreed well with the small amount of telemetry data obtained from Flight F-001. Figure 4-3 shows the telemetry data during the critical phases of Flight F-002. Examination of the trajectory data showed that the deceleration of the vehicle after fairing deployment was lower than anticipated, as shown in Figure 4-4. Since the parachute is deployed by a timer, this resulted in parachute deployment at 320 psf, nearly double the design dynamic pressure of 180 psf. The parachute system was redesigned to be able to withstand deployment at this higher dynamic pressure, and rocket sled tests (discussed in Section 3.3) were conducted to verify its effectiveness.

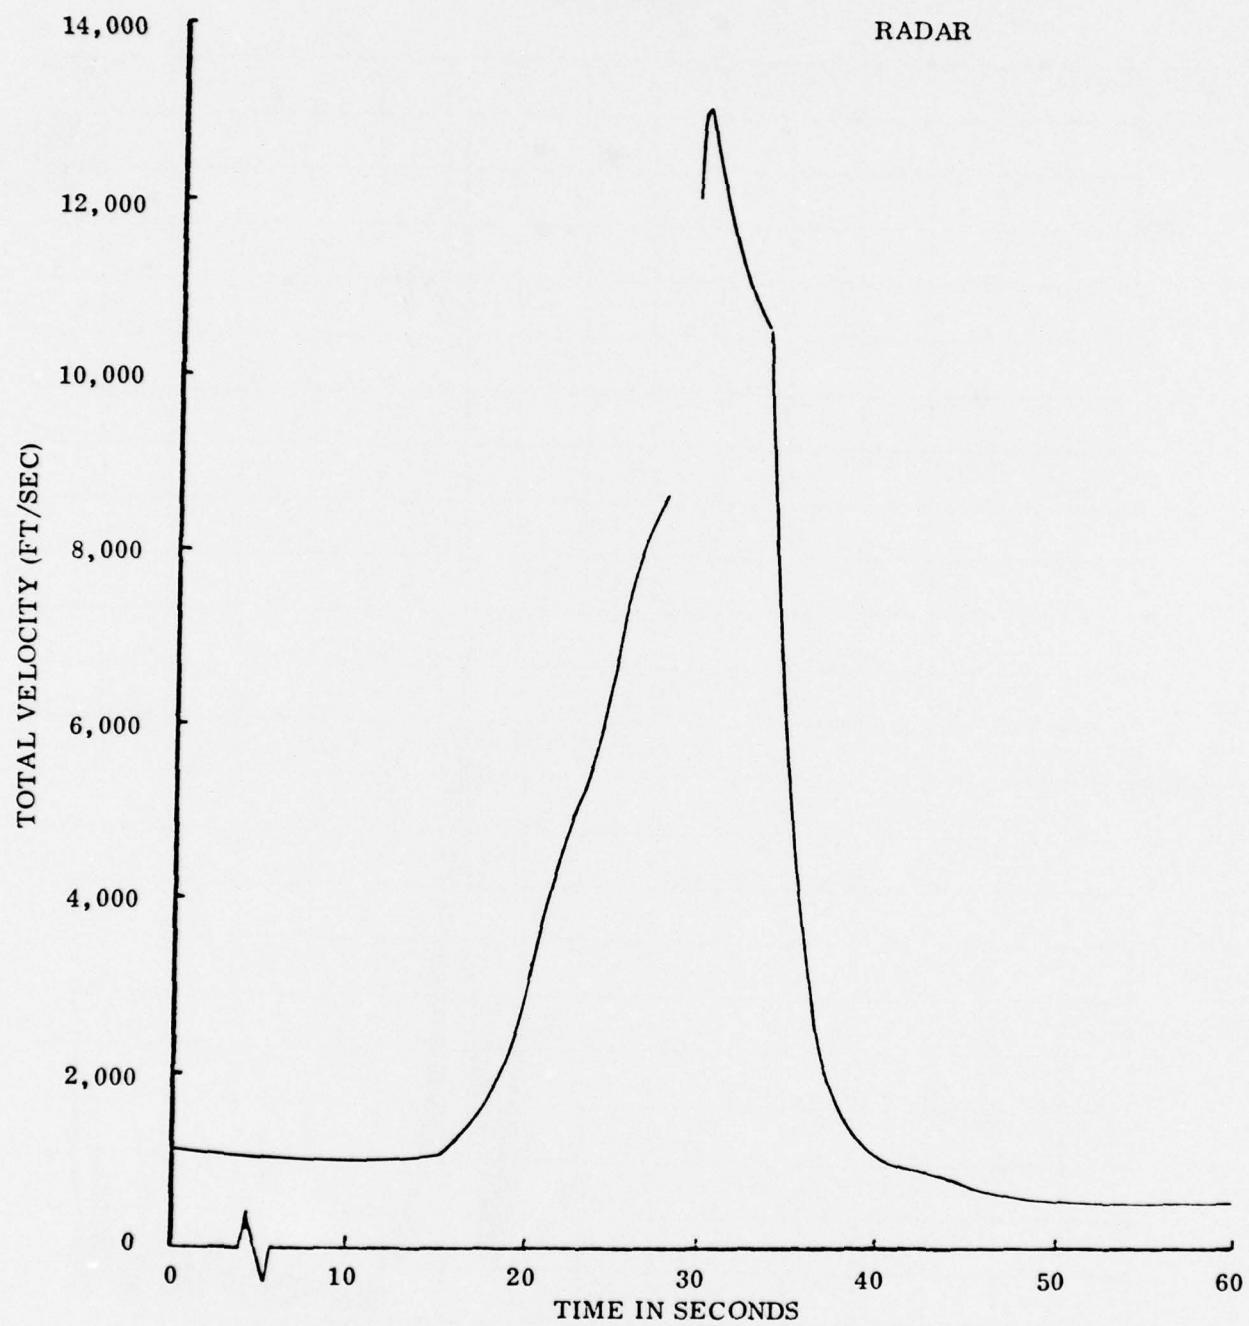
Figure 4-5. FLAME F-002 velocity history.

DESIGN AND DROP TEST 180 PSF 400 FT/SEC

FLIGHT TEST 320 PSF 620 FT/SEC

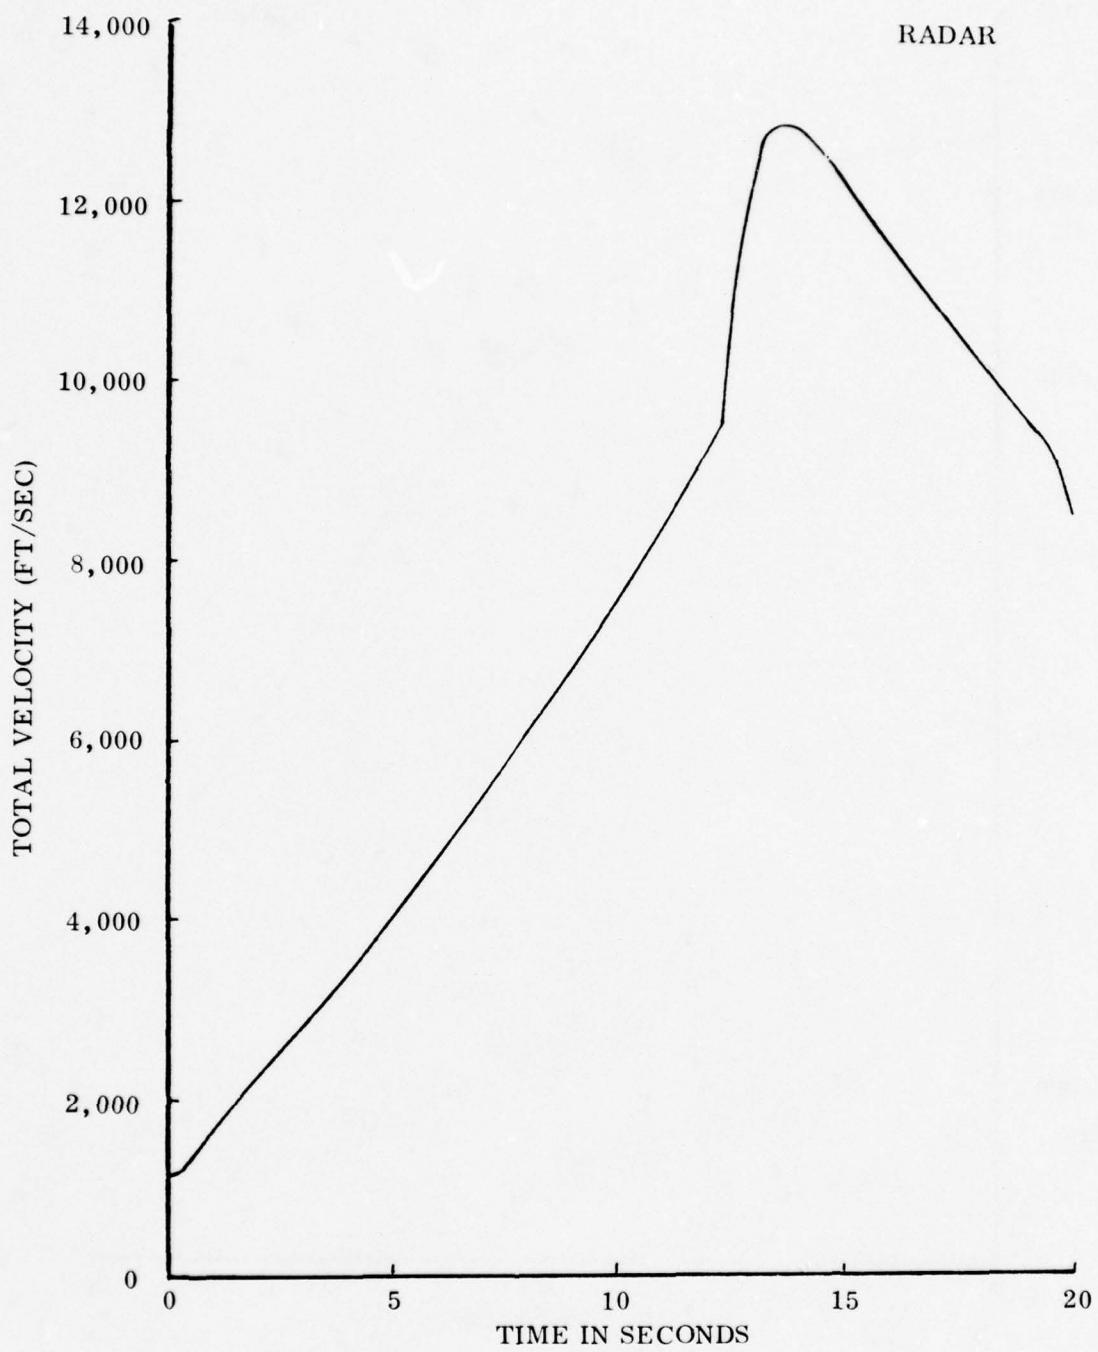
Figure 4-8. FLAME F-003 velocity history.

Since the vehicle drag after fairing deployment was less than that due to mass change alone, it was concluded that the fairing sections did not separate from the vehicle after the pyrotechnics fired. It is thought that only one side was completely cut, causing the fairing to spread and slip back over the drogue. Extremely high local heating caused by shock wave impingement then burned through the drogue heatshield and substructure, destroying the telemetry and transponder.

A detailed re-examination of the fairing deployment system was then conducted resulting in the conclusion that either 1) one or more of the pyrotechnic devices did not function, or 2) the bolts that held the two fairing segments together during assembly had never been removed. The following procedural and pyrotechnic system changes were developed to ensure against a recurrence of either possible cause:

- INCOMPLETE ORDNANCE FUNCTION (ONE SHAPED CHARGE DID NOT COMPLETELY CUT FAIRING)
- BALLAST BOLTS NOT REMOVED

A ground test (described in Section 3.4) of the redesigned system was then conducted, and the system was found to function properly.

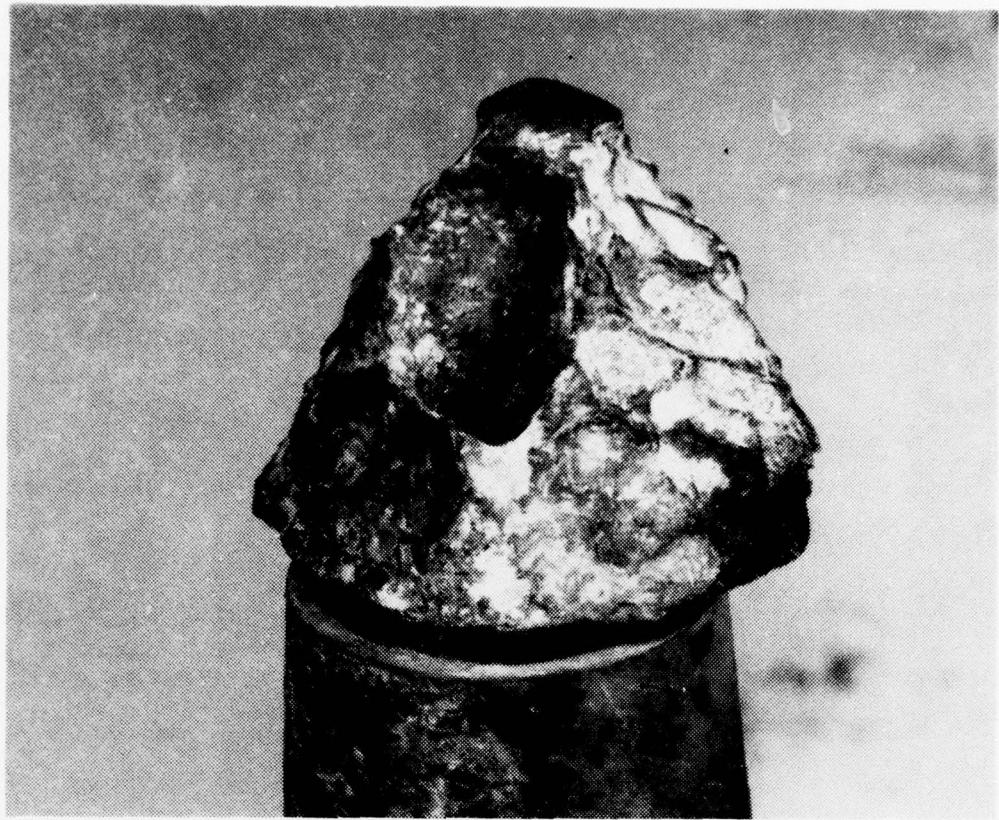
Figure 4-27. Recovered gasjet nosetip from FLAME F-008.

Examination of the optical data and the recovered vehicle indicated that the gas generator for the nosetip exploded during fairing deployment. The optical data showed a large quantity of debris released at that time, and the vehicle emitted a plume of burning material for sometime thereafter. The recovered nosetip is consistent with the hypothesis that the gas generator burst during fairing deployment. Table 4-21 lists the critical mission parameters and Table 4-22 summarizes conclusions reached from the mission. Figures 4-28 through 4-30 present the trajectory obtained from optical tracking data.

- Boost system performance was successful.
- Fairing deployment was successful.
- The nosetip gas generator apparently failed at fairing deployment.
- The chute did not deploy and the vehicle impacted supersonically.
- The majority of vehicle was recovered from the impact site. Analysis of the nosetip suggests that gas flow ceased at side panel deployment.
